COUNTY OF KINGS

Pedestrian Signals

Transition Plan

February 2016

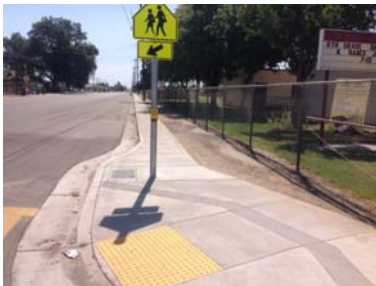
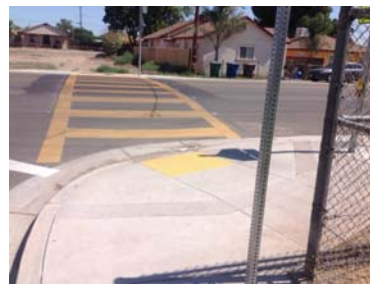
5341 • *As-Built Description:*

SE Pedestrian Signal

A crosswalk with pedestrian signal indication does not have the audible signal device integrated into the signal device.

Accessible Path	(y/n)	Yes
Clear Floor Space	(y/n)	Yes
Clear Floor Slope	(%)	1.5
Clear Floor X Slope	(%)	0.3
Button Ht.	(in)	40
Button Reach	(in)	0
Button Diameter	(in)	2
Button Pressure	(lbs)	1
Closed Fist Operation	(y/n)	Yes
Visual Contrast	(y/n)	Not
Contrasting Color Bands	(y/n)	No
Vibrotactile Feedback	(y/n)	No
Audible Walk Indicator	(y/n)	No
Button Locator Tone	(y/n)	No
Directional Info	(y/n)	Not Tactile
Within 5 ft from crosswalk	(y/n)	Yes
1.5 - 6.0 ft from curb	(y/n)	Yes
10 ft minimum separation		N/A

Integrate the audible signal device with the pedestrian pushbutton.

Provide 2" wide color coding with 1" wide dark borders located directly above control button.
Provide a button locator tone.

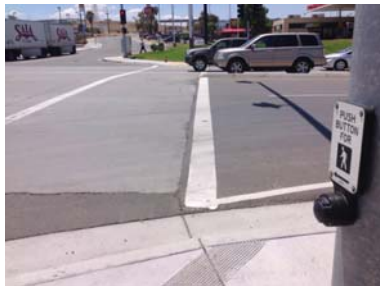
5345 • *As-Built Description:*

NE Pedestrian Signal

A crosswalk with pedestrian signal indication does not have the audible signal device integrated into the signal device.

Accessible Path	(y/n)	Yes
Clear Floor Space	(y/n)	Yes
Clear Floor Slope	(%)	1.0
Clear Floor X Slope	(%)	0.1
Button Ht.	(in)	36.5
Button Reach	(in)	0
Button Diameter	(in)	2
Button Pressure	(lbs)	1
Closed Fist Operation	(y/n)	Yes
Visual Contrast	(y/n)	No
Contrasting Color Bands	(y/n)	No
Vibrotactile Feedback	(y/n)	No
Audible Walk Indicator	(y/n)	No
Button Locator Tone	(y/n)	No
Directional Info	(y/n)	Not Tactile
Within 5 ft from crosswalk	(y/n)	Yes
1.5 - 6.0 ft from curb	(y/n)	Yes
10 ft minimum separation		N/A

Integrate the audible signal device with the pedestrian pushbutton.

Provide 2" wide color coding with 1" wide dark borders located directly above control button.
Provide a button locator tone.

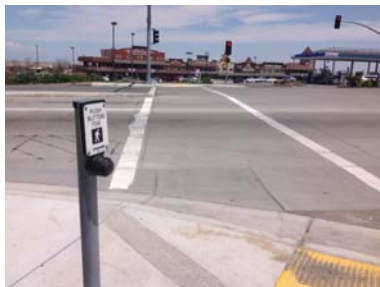
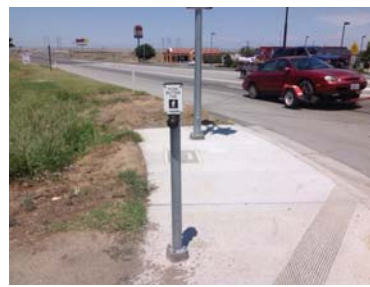
5344 • *As-Built Description:*

NW Pedestrian Signal

A crosswalk with pedestrian signal indication does not have the audible signal device integrated into the signal device.

Accessible Path	(y/n)	Yes
Clear Floor Space	(y/n)	Yes
Clear Floor Slope	(%)	1.7
Clear Floor X Slope	(%)	1.1
Button Ht.	(in)	42
Button Reach	(in)	0
Button Diameter	(in)	2
Button Pressure	(lbs)	1
Closed Fist Operation	(y/n)	Yes
Visual Contrast	(y/n)	No
Contrasting Color Bands	(y/n)	No
Vibrotactile Feedback	(y/n)	No
Audible Walk Indicator	(y/n)	No
Button Locator Tone	(y/n)	No
Directional Info	(y/n)	Not Tactile
Within 5 ft from crosswalk	(y/n)	Yes
1.5 - 6.0 ft from curb	(y/n)	Yes
10 ft minimum separation		N/A

Integrate the audible signal device with the pedestrian pushbutton.

Provide 2" wide color coding with 1" wide dark borders located directly above control button.
Provide a button locator tone.

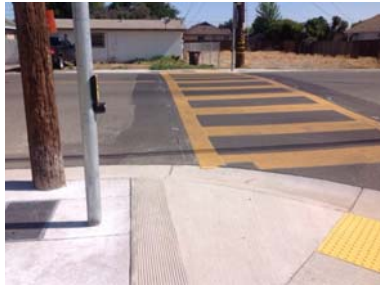
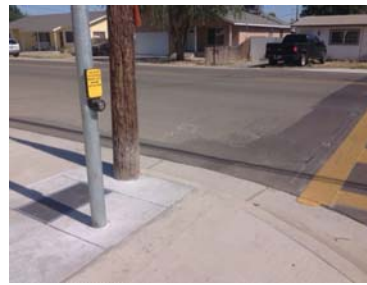
5338 • *As-Built Description:*

SW Clear Floor Space

Slope(s) of the floor or ground surface at the pedestrian signal device exceed 1:48 (2%) in any direction.

• *As-is Measurement:* 2.6%

Accessible Path	(y/n)	Yes
Clear Floor Space	(y/n)	Yes
Clear Floor Slope	(%)	2.6
Clear Floor X Slope	(%)	0.9
Button Ht.	(in)	40
Button Reach	(in)	0
Button Diameter	(in)	2
Button Pressure	(lbs)	1
Closed Fist Operation	(y/n)	Yes
Visual Contrast	(y/n)	Yes
Contrasting Color Bands	(y/n)	No
Vibrotactile Feedback	(y/n)	No
Audible Walk Indicator	(y/n)	No
Button Locator Tone	(y/n)	No
Directional Info	(y/n)	Not Tactile
Within 5 ft from crosswalk	(y/n)	Yes
1.5 - 6.0 ft from curb	(y/n)	Yes
10 ft minimum separation		N/A

Modify or repave the ground surface as necessary to provide slope(s) not exceeding the required 1:48 (2%) maximum in any direction.

Provide 2" wide color coding with 1" wide dark borders located directly above control button.
 Provide voice or tone audible indication of the WALK interval at the pedestrian signal device.
 Provide a button locator tone.

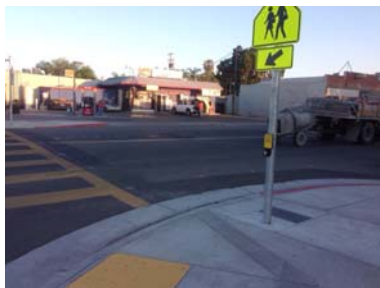
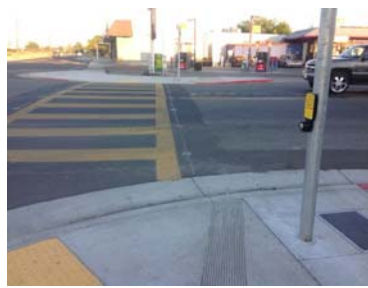
5342 • *As-Built Description:*

NE Pedestrian Signal

A crosswalk with pedestrian signal indication does not have the audible signal device integrated into the signal device.

Accessible Path	(y/n)	Yes
Clear Floor Space	(y/n)	Yes
Clear Floor Slope	(%)	0.8
Clear Floor X Slope	(%)	0.4
Button Ht.	(in)	40
Button Reach	(in)	0
Button Diameter	(in)	2
Button Pressure	(lbs)	1
Closed Fist Operation	(y/n)	Yes
Visual Contrast	(y/n)	Yes
Contrasting Color Bands	(y/n)	No
Vibrotactile Feedback	(y/n)	No
Audible Walk Indicator	(y/n)	No
Button Locator Tone	(y/n)	No
Directional Info	(y/n)	Not Tactile
Within 5 ft from crosswalk	(y/n)	Yes
1.5 - 6.0 ft from curb	(y/n)	Yes
10 ft minimum separation		N/A

Integrate the audible signal device with the pedestrian pushbutton.

Provide 2" wide color coding with 1" wide dark borders located directly above control button.
Provide a button locator tone.

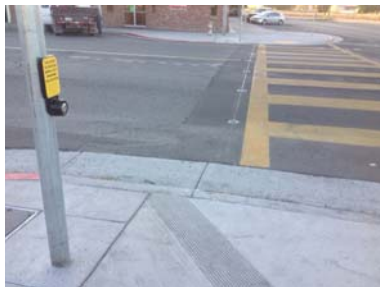
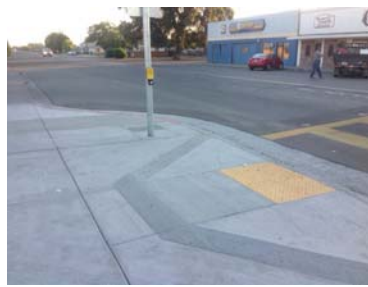
5343 • *As-Built Description:*

NW Pedestrian Signal

A crosswalk with pedestrian signal indication does not have the audible signal device integrated into the signal device.

Accessible Path	(y/n)	Yes
Clear Floor Space	(y/n)	Yes
Clear Floor Slope	(%)	0.8
Clear Floor X Slope	(%)	1.0
Button Ht.	(in)	40
Button Reach	(in)	0
Button Diameter	(in)	2
Button Pressure	(lbs)	1
Closed Fist Operation	(y/n)	Yes
Visual Contrast	(y/n)	Yes
Contrasting Color Bands	(y/n)	No
Vibrotactile Feedback	(y/n)	No
Audible Walk Indicator	(y/n)	No
Button Locator Tone	(y/n)	No
Directional Info	(y/n)	Not Tactile
Within 5 ft from crosswalk	(y/n)	Yes
1.5 - 6.0 ft from curb	(y/n)	Yes
10 ft minimum separation		N/A

Integrate the audible signal device with the pedestrian pushbutton.

Provide 2" wide color coding with 1" wide dark borders located directly above control button.
Provide a button locator tone.

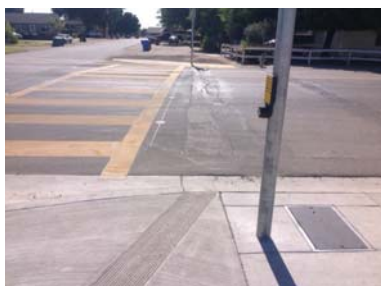
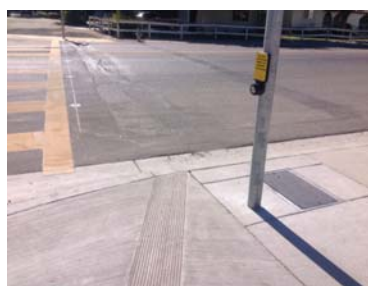
5336 • *As-Built Description:*

SW Pedestrian Signal

A crosswalk with pedestrian signal indication does not have the audible signal device integrated into the signal device.

Accessible Path	(y/n)	Yes
Clear Floor Space	(y/n)	Yes
Clear Floor Slope	(%)	0.7
Clear Floor X Slope	(%)	0.5
Button Ht.	(in)	40
Button Reach	(in)	0
Button Diameter	(in)	2
Button Pressure	(lbs)	1
Closed Fist Operation	(y/n)	Yes
Visual Contrast	(y/n)	Yes
Contrasting Color Bands	(y/n)	No
Vibrotactile Feedback	(y/n)	No
Audible Walk Indicator	(y/n)	No
Button Locator Tone	(y/n)	No
Directional Info	(y/n)	Not Tactile
Within 5 ft from crosswalk	(y/n)	Yes
1.5 - 6.0 ft from curb	(y/n)	Yes
10 ft minimum separation		N/A

Integrate the audible signal device with the pedestrian pushbutton.

Provide 2" wide color coding with 1" wide dark borders located directly above control button.
Provide a button locator tone.

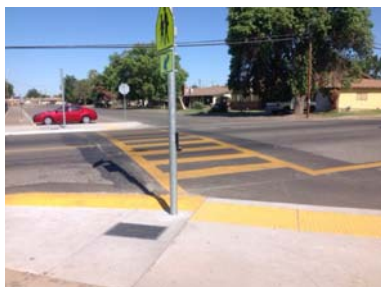
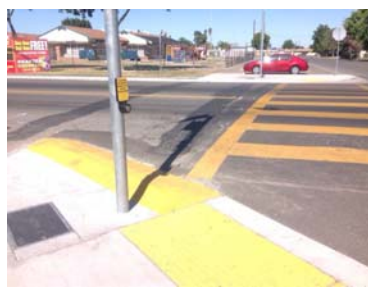
5337 • *As-Built Description:*

SW Pedestrian Signal

A crosswalk with pedestrian signal indication does not have the audible signal device integrated into the signal device.

Accessible Path	(y/n)	Yes
Clear Floor Space	(y/n)	Yes
Clear Floor Slope	(%)	0.2
Clear Floor X Slope	(%)	1.4
Button Ht.	(in)	39
Button Reach	(in)	0
Button Diameter	(in)	2
Button Pressure	(lbs)	1
Closed Fist Operation	(y/n)	Yes
Visual Contrast	(y/n)	Yes
Contrasting Color Bands	(y/n)	No
Vibrotactile Feedback	(y/n)	No
Audible Walk Indicator	(y/n)	No
Button Locator Tone	(y/n)	No
Directional Info	(y/n)	Not Tactile
Within 5 ft from crosswalk	(y/n)	Yes
1.5 - 6.0 ft from curb	(y/n)	Yes
10 ft minimum separation		N/A

Integrate the audible signal device with the pedestrian pushbutton.

Provide 2" wide color coding with 1" wide dark borders located directly above control button.
Provide a button locator tone.

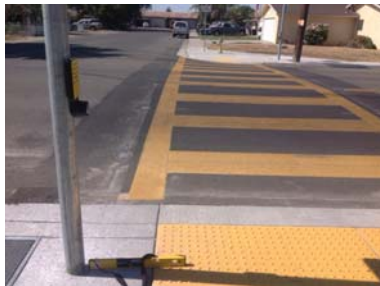
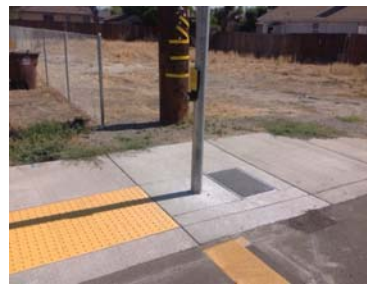
5339 • *As-Built Description:*

NW Pedestrian Signal

A crosswalk with pedestrian signal indication does not have the audible signal device integrated into the signal device.

Accessible Path	(y/n)	Yes
Clear Floor Space	(y/n)	Yes
Clear Floor Slope	(%)	1.5
Clear Floor X Slope	(%)	0.7
Button Ht.	(in)	40
Button Reach	(in)	0
Button Diameter	(in)	2
Button Pressure	(lbs)	1
Closed Fist Operation	(y/n)	Yes
Visual Contrast	(y/n)	Yes
Contrasting Color Bands	(y/n)	No
Vibrotactile Feedback	(y/n)	No
Audible Walk Indicator	(y/n)	No
Button Locator Tone	(y/n)	No
Directional Info	(y/n)	Not Tactile
Within 5 ft from crosswalk	(y/n)	Yes
1.5 - 6.0 ft from curb	(y/n)	Yes
10 ft minimum separation		N/A

Integrate the audible signal device with the pedestrian pushbutton.

Provide 2" wide color coding with 1" wide dark borders located directly above control button.
Provide a button locator tone.

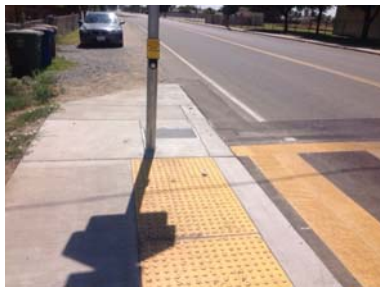
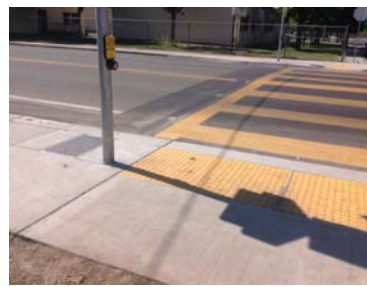
5340 • *As-Built Description:*

NE Pedestrian Signal

A crosswalk with pedestrian signal indication does not have the audible signal device integrated into the signal device.

Accessible Path	(y/n)	Yes
Clear Floor Space	(y/n)	Yes
Clear Floor Slope	(%)	0.1
Clear Floor X Slope	(%)	0.2
Button Ht.	(in)	40
Button Reach	(in)	0
Button Diameter	(in)	2
Button Pressure	(lbs)	1
Closed Fist Operation	(y/n)	Yes
Visual Contrast	(y/n)	Yes
Contrasting Color Bands	(y/n)	No
Vibrotactile Feedback	(y/n)	No
Audible Walk Indicator	(y/n)	No
Button Locator Tone	(y/n)	No
Directional Info	(y/n)	Not Tactile
Within 5 ft from crosswalk	(y/n)	Yes
1.5 - 6.0 ft from curb	(y/n)	Yes
10 ft minimum separation		N/A

Integrate the audible signal device with the pedestrian pushbutton.

Provide 2" wide color coding with 1" wide dark borders located directly above control button.
Provide a button locator tone.
